**Preliminary Site Survey: Bay-Waveland Yacht Club Harbor,  
Bay St Louis, Mississippi**

Mississippi Office of Geology

Coastal Division

September 20, 1999

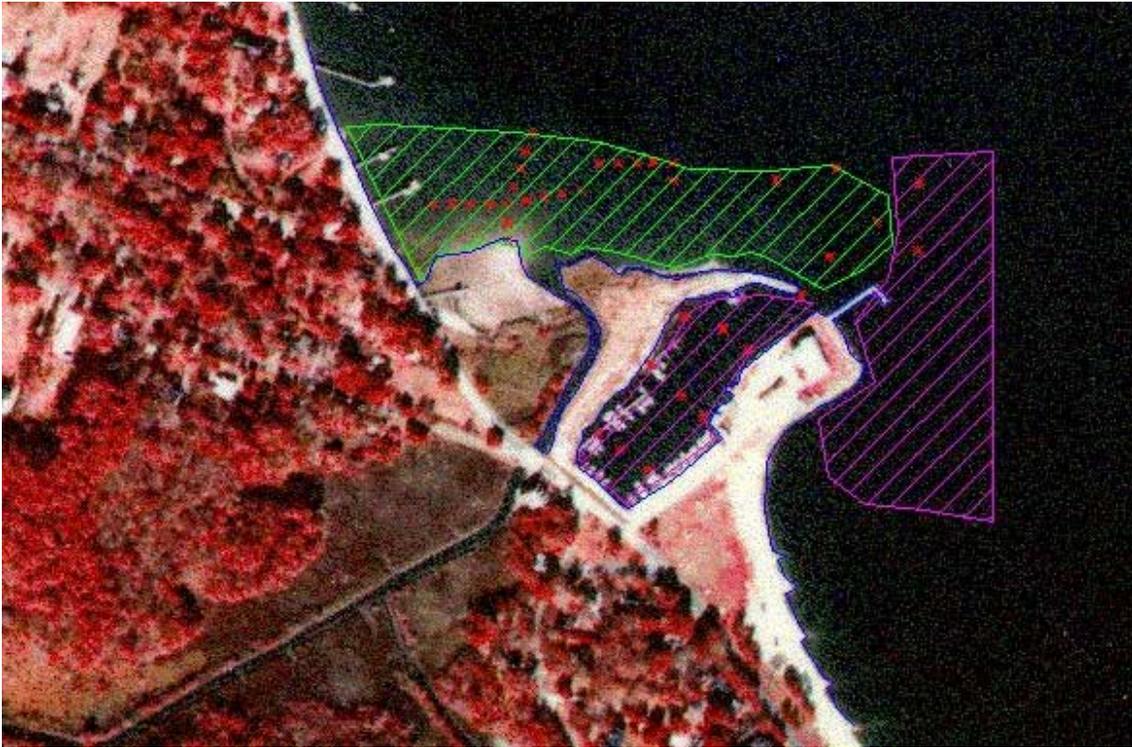
*Figure 4. Red crosses are sample locations, purple hatched areas represent mud bottom, and green hatched areas represent sandy bottom. Note that the sand shoal can be seen in the 1992 color infrared aerial photo.*

An 80 to 100 meter wide sand bar (Figure 4) has migrated across the front of the harbor entrance; it begins along the northern shore and pinches out offshore of the yacht club pier. Near the harbor entrance the sand overlies mud and sandy mud, just to the west the sand is underlain by an ancient oyster reef, further west the sand overlies a thick deposit of muddy sand. The sand body is 1 to 2 ft thick near the harbor entrance and increases to 5+ ft to the west, near the creek mouth. The change in deposition from muddy sediments to sand indicates a different depositional pattern and is probably responsible for the formation of the sand bar. The extensive sand platform at the head of the creek is the source of sediment feeding the migrating bar. It does not appear that the creek is contributing sediment, it is more likely that either the sediment has been slowly but continuously building up since the construction of the harbor and there is now enough sand above wave base to allow transport beyond the trapped area; or alternately, the sand is a result of a sporadic event (hurricane) that is migrating down drift. Offshore of the sand bar the sediment is shelly mud, similarly south of the bar the sediment is also shelly mud.

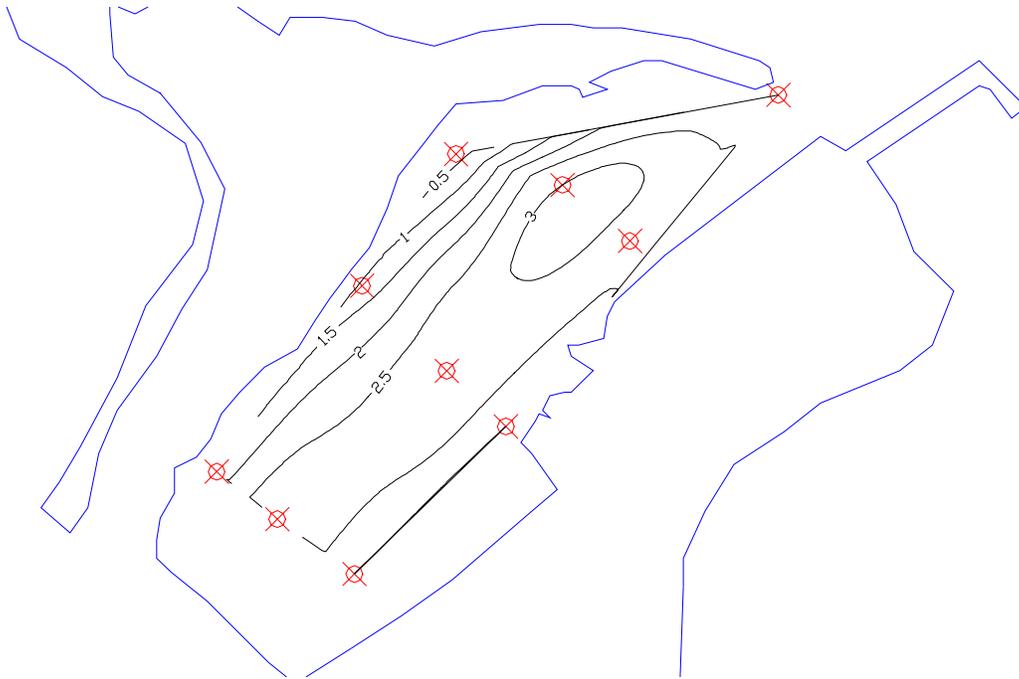
The sediment inside the harbor and away from the immediate shoreline was generally mud or sandy mud (mostly mud with some sand) with the exception of one location on the northeast portion of the inner harbor where there was muddy sand (mostly sand with some mud) and a live oyster reef. Sediment thicknesses ranged from 1 ft near the oyster reef (muddy sand) to 9 ft (mud) in the central portion of the harbor. Sandy sediments are dominant along the northern shoreline out to about 1-ft of depth, at which point the depth increases rapidly (dredged area) and the sediments become muddy. The sampling technique limited the description of the entire sediment column, but in samples near the southern bulkheads and near the harbor entrance there is significantly more shell material throughout. It is not clear whether this is an indication of runoff from the parking lot (which may be built over oyster shell fill) or a submerged source. The bulkheads appeared to have areas that were prone to sediments washing out. Similarly, the northwestern end the harbor shows some signs of runoff from the adjacent creek. These two sources are, or, appear to be relatively minor. The mud filling the central harbor is loose and consistently soft indicating recent and continuous deposition. Taken in total the harbor contains approximately 25,000 cubic meters of soft mud, which, when de-watered, will probably be on the order of 5,000-10,000 cubic meters. This is a fairly substantial quantity that would be very noticeable if coming only from small sources (parking lot, adjacent creek).

*Figure 5. Harbor sediment thickness (not depths) in meters, crosses are sample locations.*

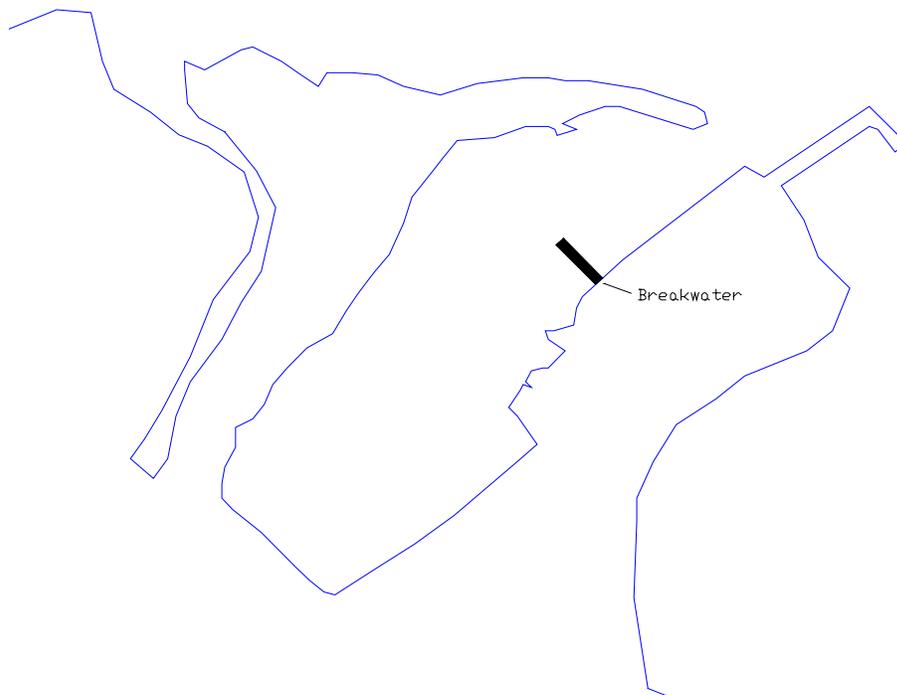
Some mention of the rough conditions in the harbor was brought to our attention. Waves from the east-northeast do enter the harbor and are probably refracted along by the southern bulkhead. A 20-meter (65-ft) wooden breakwater, extending down several ft below the water surface, at the end of the docking space may stop the refracted waves from continuing into the harbor and allow for ample navigation room (assuming the harbor is dredged).

*Figure 6. Location of 20-meter breakwater to reduce wave propagation along southern bulkhead and allow for safe navigation in and out of harbor.*
