**Biennial Report of Sand Beaches;  
Hancock County, 1999**

**OPEN-FILE REPORT 110**

**Mississippi Department of Environmental Quality**

**March 2000**

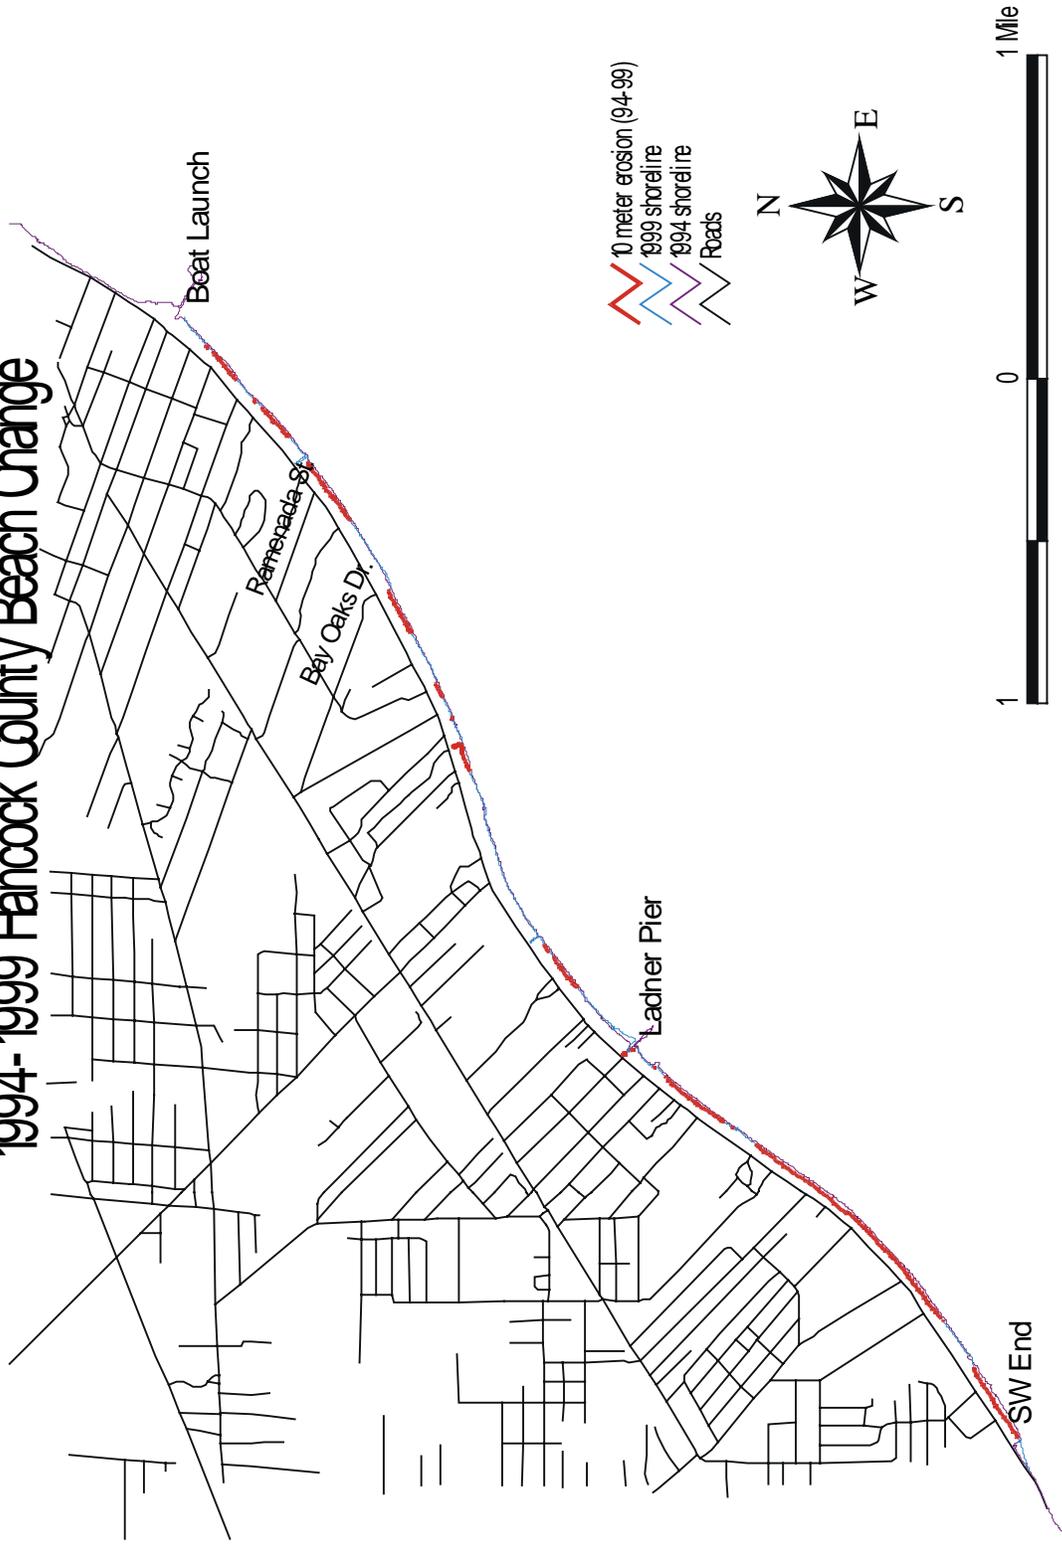
# 1994-1999 Hancock County Beach Change

Looking at the slightly longer range, from 1994 to 1999, and encompassing the life of the present renourished beach it is clear that most of the shoreline is retreating (Figure 2). A 10-meter (33-foot) setback from the 1994 shoreline was computed along the length of the beach. Any portion of the 1999 shoreline that is beyond this setback is highlighted in red and represents more than 2 meters of retreat per year (6 feet/year). Again, areas in the middle stretch of the beach, especially east of Ladner Pier, were less prone to shoreline retreat than those on the ends. The slight embayment in Waveland and Ladner Pier appear to be efficiently trapping sand.

Figure 2. 1994 and 1999 shorelines with areas with more than 10 m of erosion superimposed. Notice the only area with significant accretion is next to Ladner Pier.

Shoreline retreat is only noticeable ( $>2.5$  meters/year; 8 feet/year) on the ends of the renourished beach from 1997 to 1999 (Figure 1), while nearly the entire stretch of beach has retreated more than 10 meters (33 feet) over the past five years ( $>2.0$  meters/year; 6 feet/year) (Figure 2). The one exception is the central region near the Ladner Pier. This area is possibly more protected or favorably aligned to the dominant southeast wind direction (among a list of other possibilities) and acts like a sediment sink (deposition center). This trend is also evident in the beach profile volume change, both in the short and long terms (Figures 3 and 4). Using shoreline lengths and volume changes, the beach as a whole (from seawall to mudline) has lost about 55,000 cubic yards (11,000 cubic yards/year) since 1994; from 1997 to 1999 beach loss totaled 18,000 cubic yards (9,000 cubic yards/year). Shoreline surveys and beach profiles show similar patterns, such that stretches of the beach with negative sand budgets typically coincide with areas of shoreline retreat. As such, future renourishment or supplemental maintenance should concentrate on these highlighted locations to maximize resources and reduce costs.

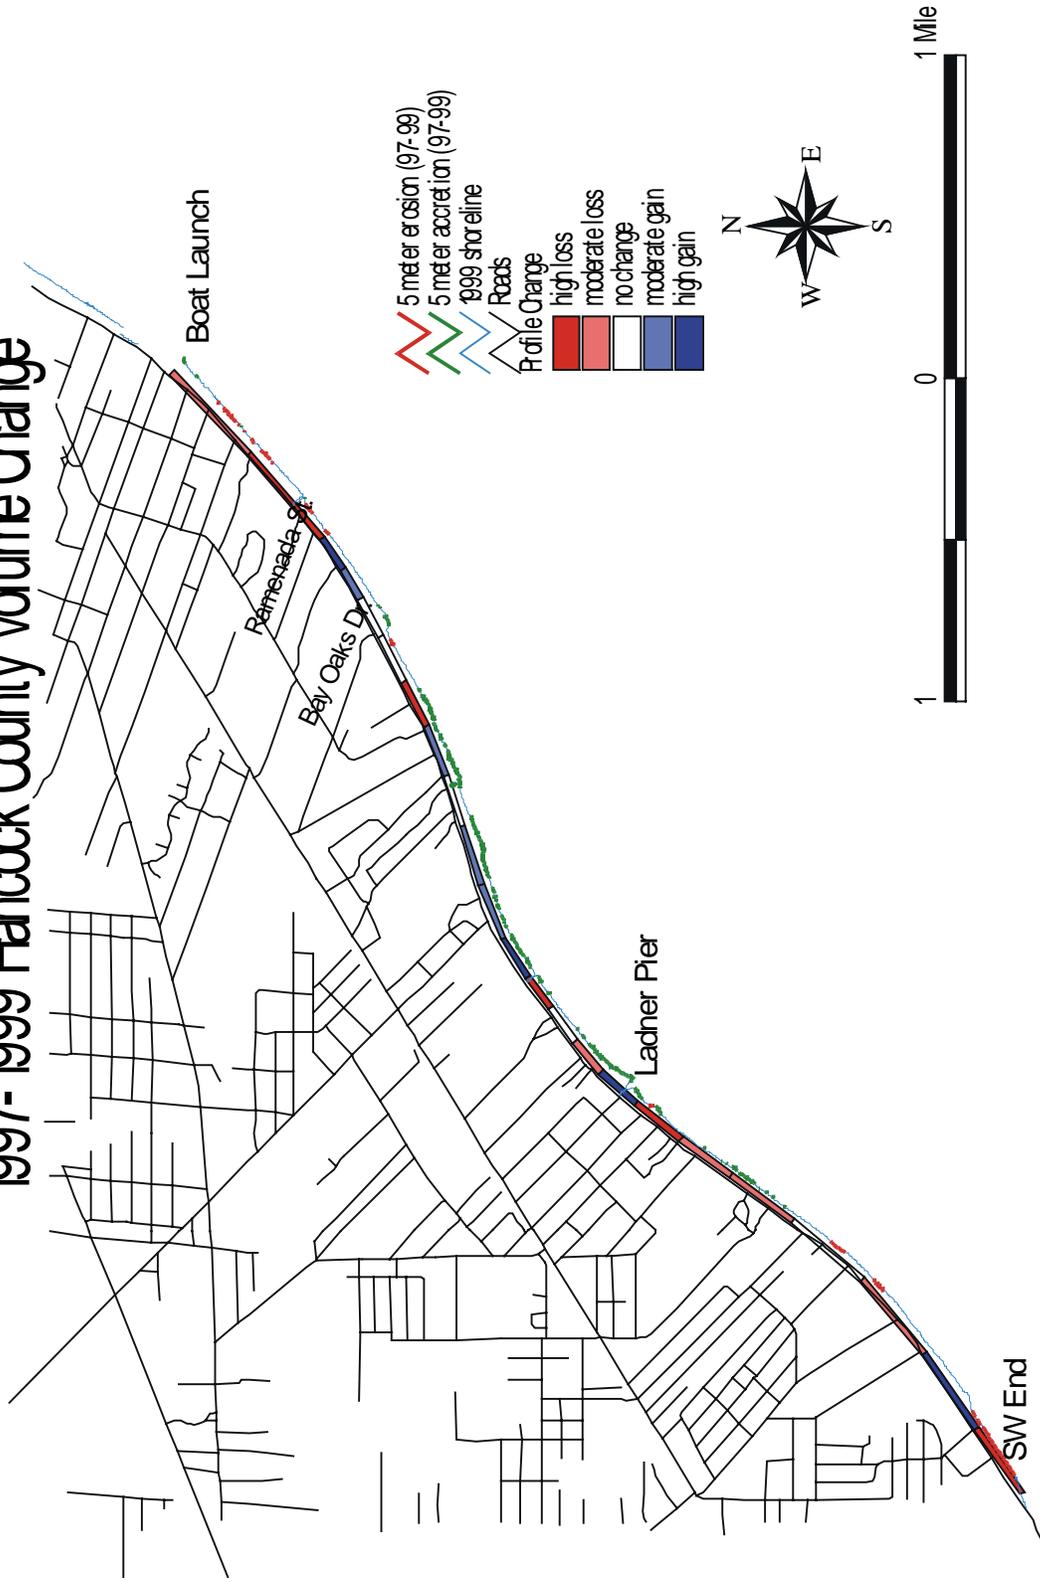
# 1997-1999 Hancock County Volume Change

Comparison of 1997 with 1999 profile data shows a negative budget at both ends of the beach (Figure 3). Profiles southwest of Ramenada St. to Ladner Pier generally have a positive budget, although there are three short segments that have negative values. This stretch of beach is also typified by shoreline advance. Southwest of Ladner Pier there is a general deficit, except for one profile location. It is clear that both the embayment (beginning between Bay Oaks Dr. and Ramenada St.) and Ladner Pier in Waveland have strong influences on the sediment movement and budget along the coast. The negative budgets at the ends of the renourished beach are not surprising, since these areas can receive sand only from one longshore direction (only sand moving northeast on the Bay St. Louis end; only sand moving southwest on the Waveland end).

Figure 3. Shoreline volume change with 1999 shoreline, erosion and accretion overlays

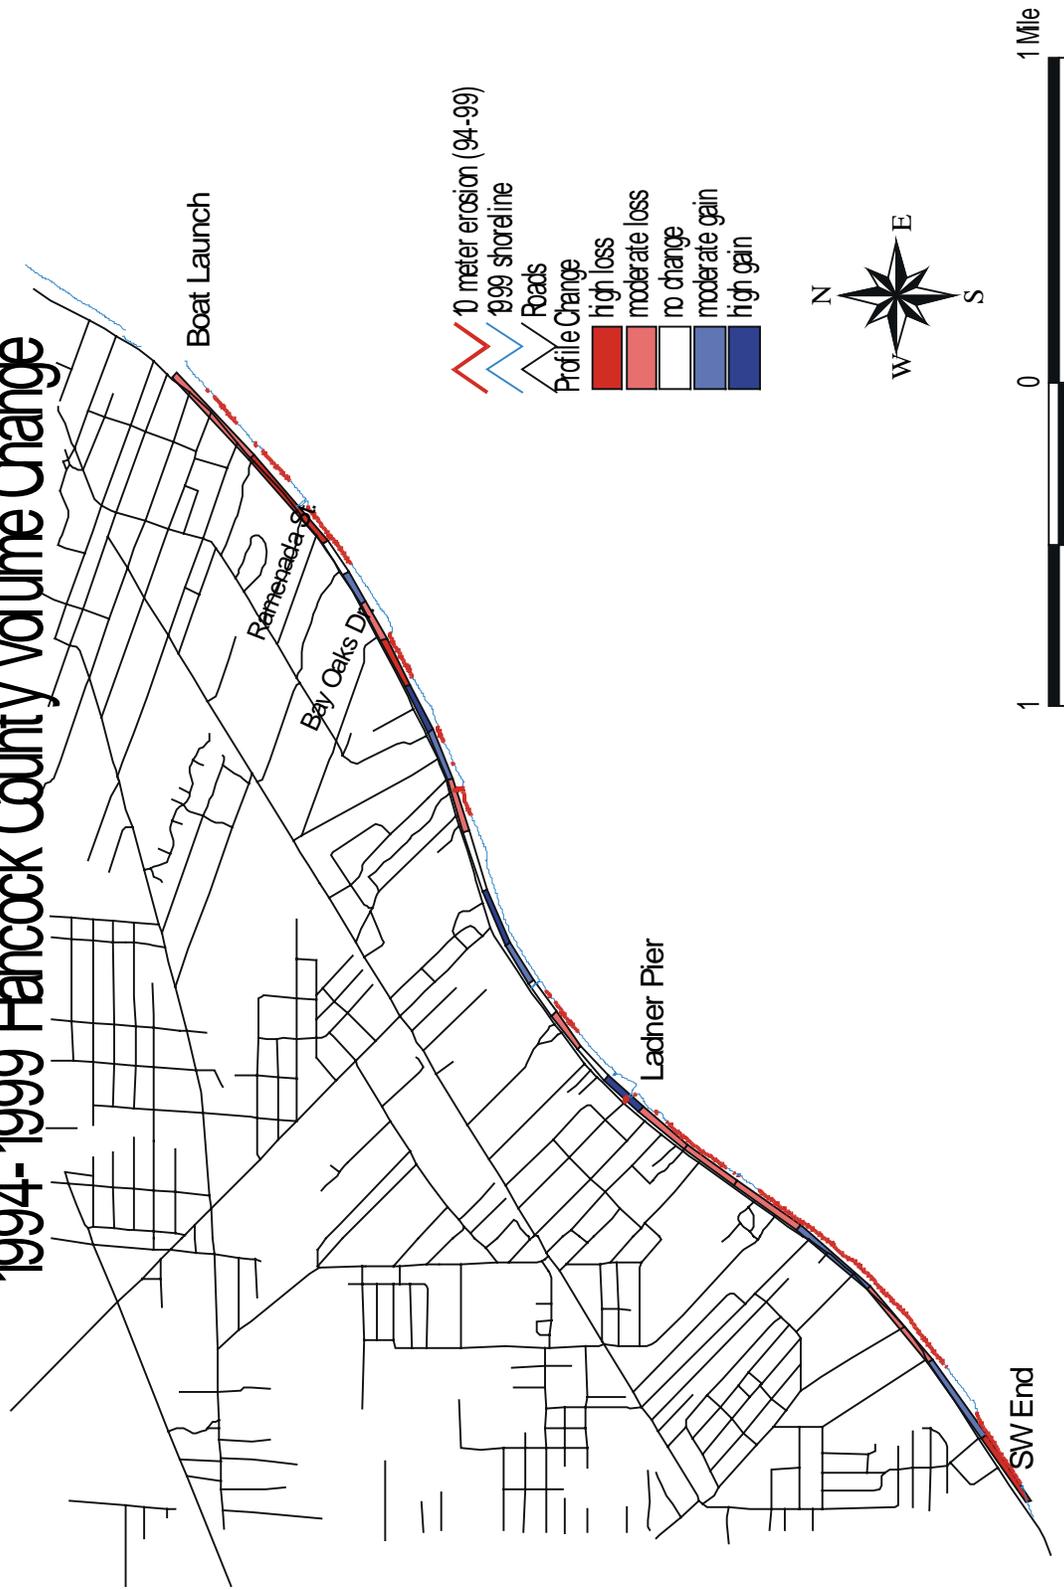
# 1994-1999 Hancock County Volume Change

Similar comparison using 1994 and 1999 profile data shows the same strong influence of the Pier and embayment in Waveland and the negative budget at the beach ends (Figure 4). The stretch of beach from the beginning of the embayment (near Bay Oaks Dr.) to the Ladner Pier is generally gaining sand volume. Notice also that this stretch is typified by fewer setbacks of more than 10 meters (33 feet). Areas to both the northeast and southwest of this stretch generally have a negative sand budget.

Figure 4. Shoreline volume change from 1994 to 1999 with 1999 shoreline and greater than 10 m of erosion overlaid.

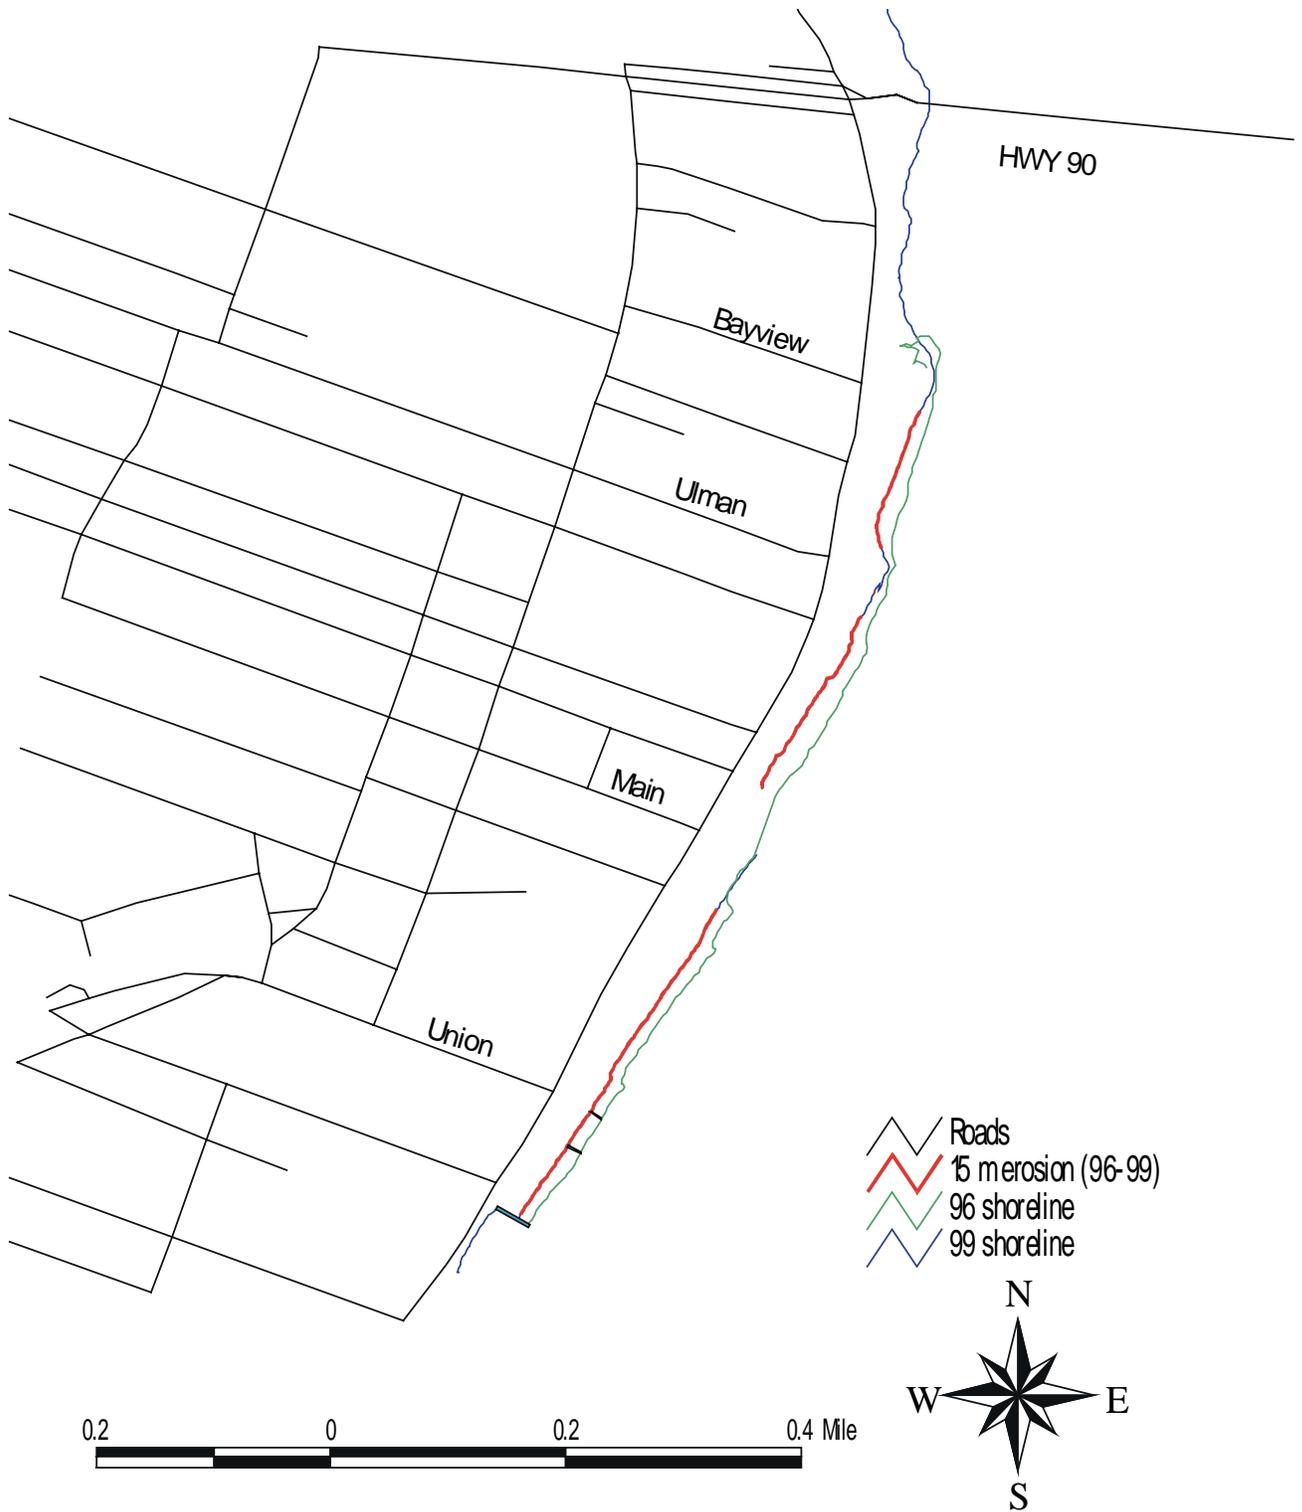
Looking at the life of the beach from 1996 to present by using a 15-meter buffer (the same 5 meter/year buffer scheme as above) (Figure 8) it is clear that most of the beach has exceeded 5 meters/year (16 feet/year) of retreat since being constructed. Comparison of Figures 7 and 8 shows that, for the most part, beach retreat has slowed since 1997; the initial loss of beach following construction is to be expected. The areas that do not follow this trend are once again on the downdrift sides of the train bridge and the pier at the end of Ulman St. This indicates that erosion will become a problem at these locations in the future if not attended to, such that the beach may become a series of disconnected stretches with the water up to the seawall behind the structures. Once the seawall is in the surf zone erosion typically increases. However, this problem is limited in scope and, thus, should be easily addressable.

Figure 8. 1996 and 1999 shorelines with erosion overlay.

Using shoreline surveys to map shoreline position, it is clear that most of the beach in front of downtown Bay St. Louis has eroded more than 15 meters (50 feet) since it was constructed. Of this setback, a significant portion occurred during the first year, which is to be expected following renourishment. A pervasive northward longshore drift controls the present erosion patterns over much of the Bay St. Louis Beach (south of Highway 90). Hurricane Georges' impact was minimal over much of the beach, except possibly exacerbating erosion on the downdrift sides of the train bridge and at the pier at Ulman St. These two areas should be monitored. A short-term solution for the erosion problems here would be to even the erosion rates along these stretches by mechanically moving sand from the south side to the north side of the structures. In comparison to the Hancock County Beach, the Bay St. Louis Beach is retreating faster and may require renourishment at problem areas in the near future. The limited size of the beach, localized erosion spots, and available maintenance equipment should allow for cost-effective solutions.
