Geomorphic Expression of Erosion on the Mississippi Gulf Coast Islands
Caused by Hurricane Georges

Keil Schmid

Mississippi Office of Geology

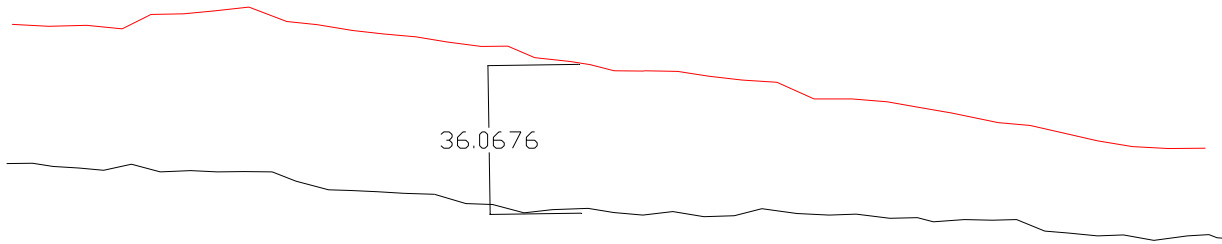
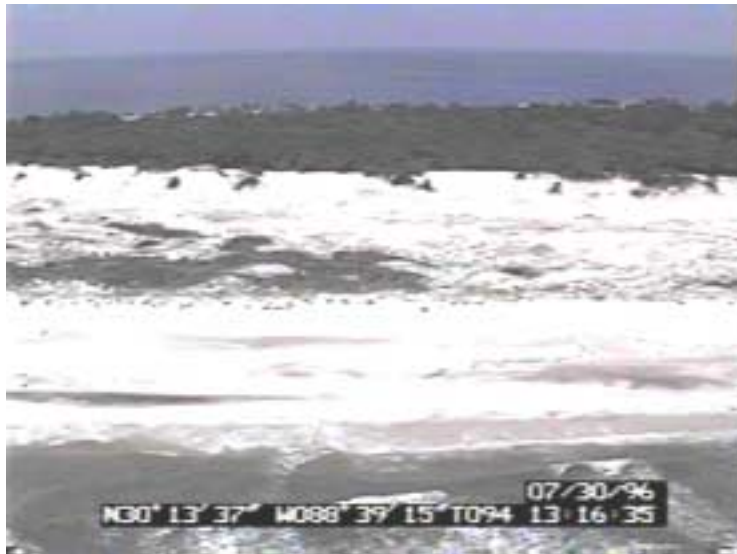
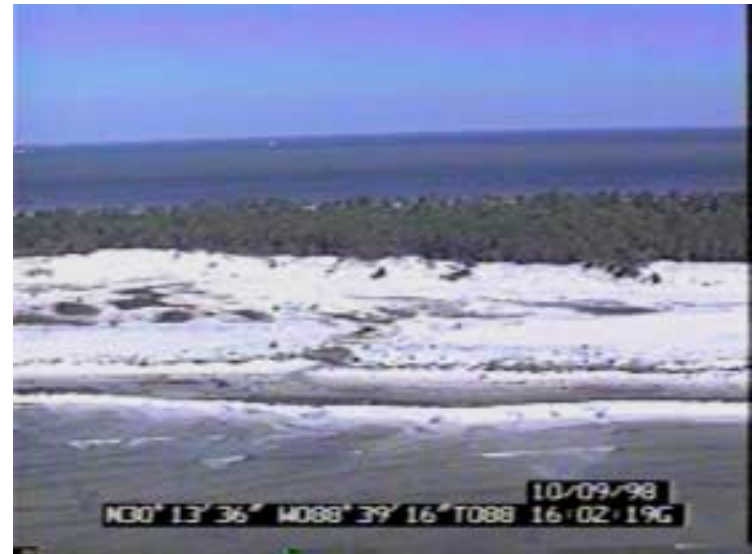
Horn Island

Wave Terraces

- Wave Terraces- experienced high erosion but did not show a distinct change in morphology; equilibrium state
- Relict Morphology- low sediment budget; out of equilibrium with conditions
- Seaward Sediment Transport- low at all but the western most island
- Sand Shoals- storm breaching widespread on all eastern islands with shoreward sediment movement
- Island recovery- transgressive sand shoals
- Populated Shorelines- Erosion Vs. Evolution

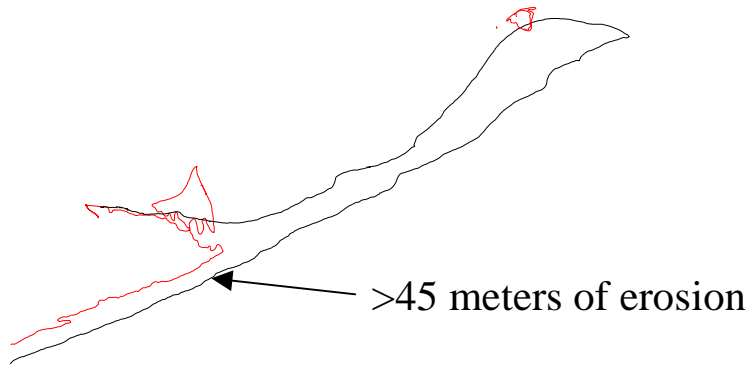
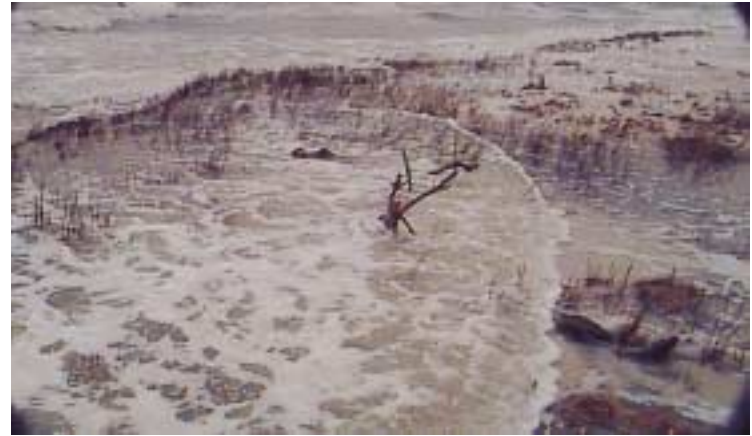
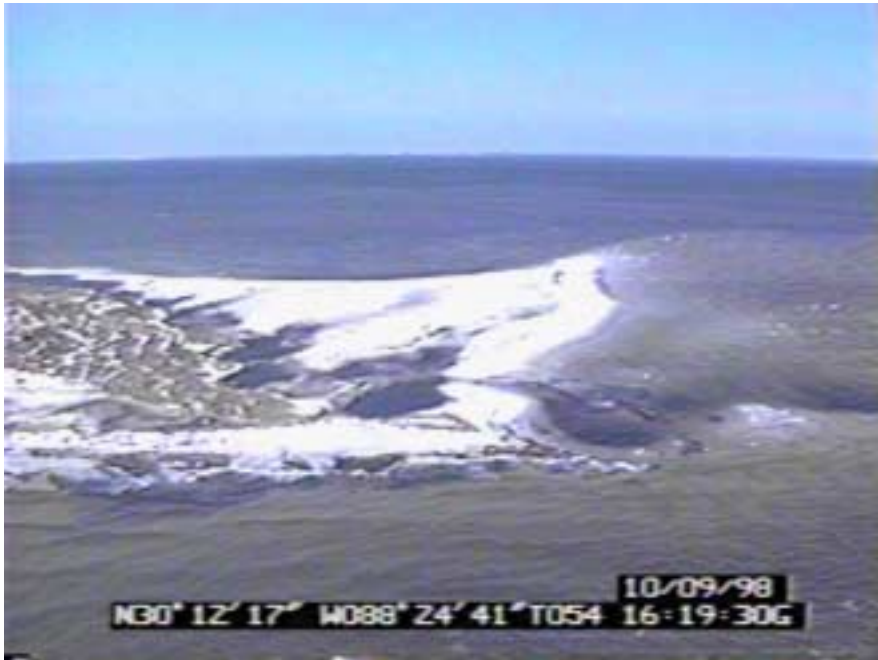
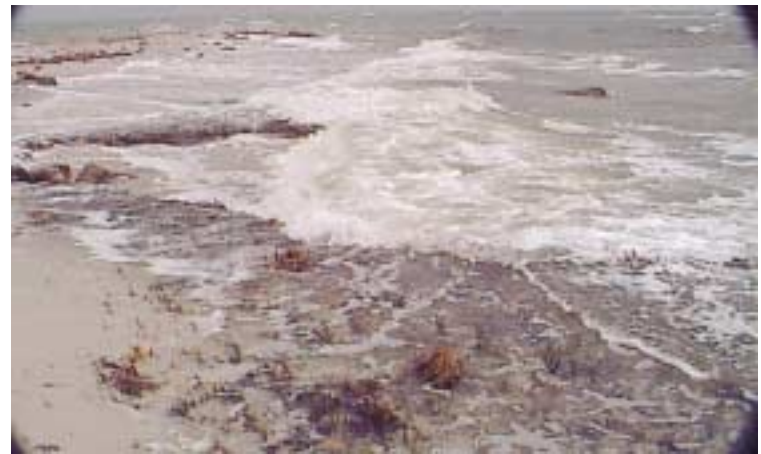
Exposed Relict Morphology

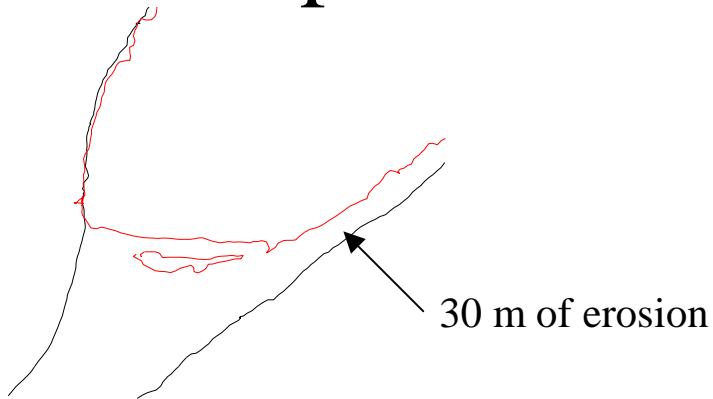
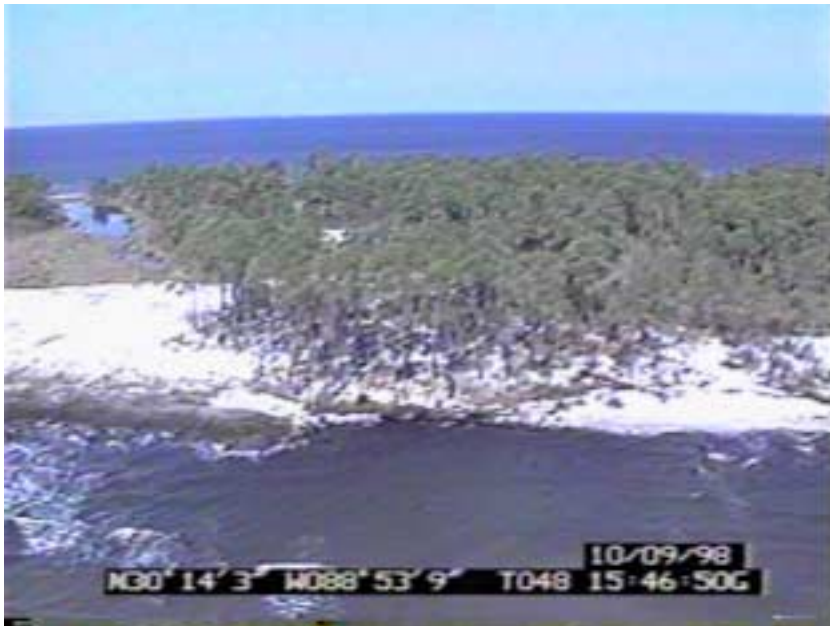
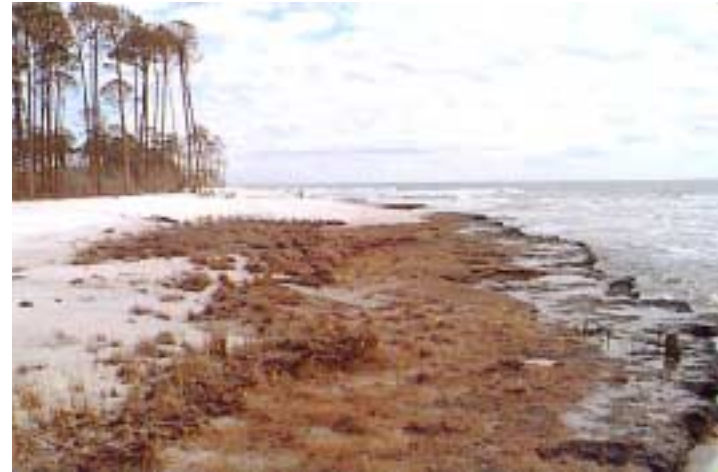
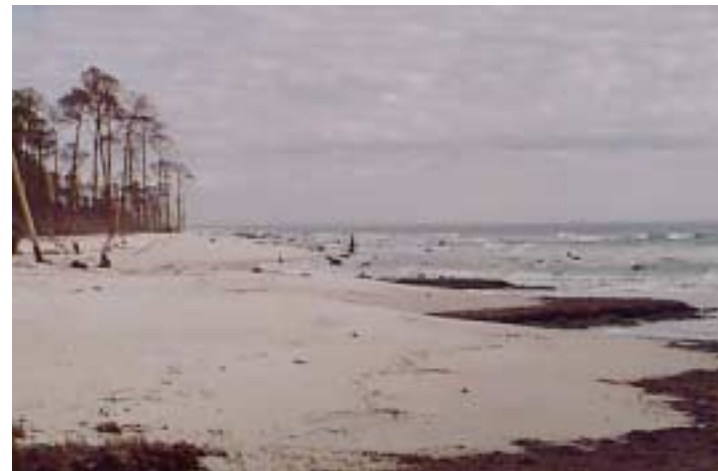
Exposed Relict Morphology:2

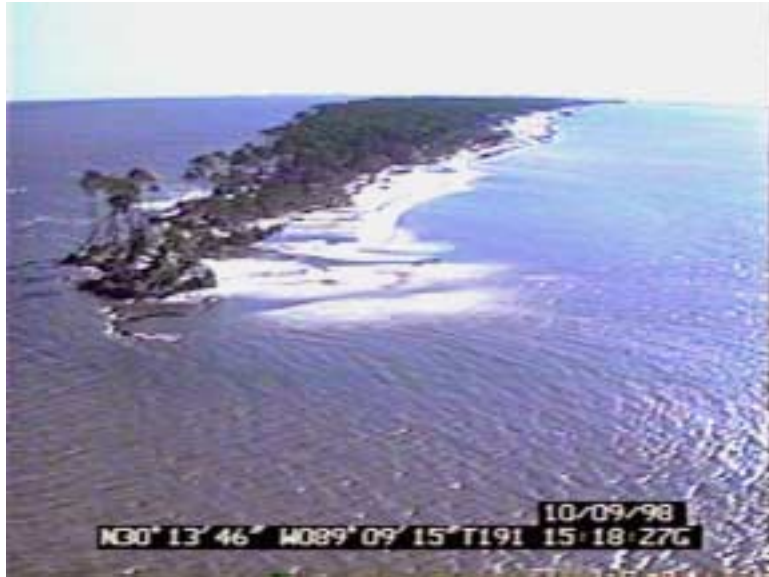
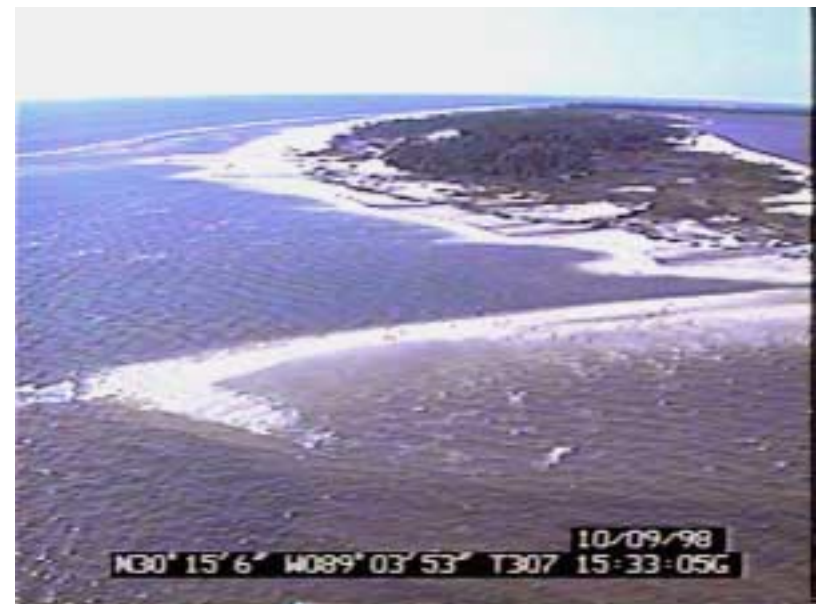
Seaward Sediment Transport

- Cat Island the most western of the studied islands
- Exhibit the highest degree of morphology associated with offshore sediment movement

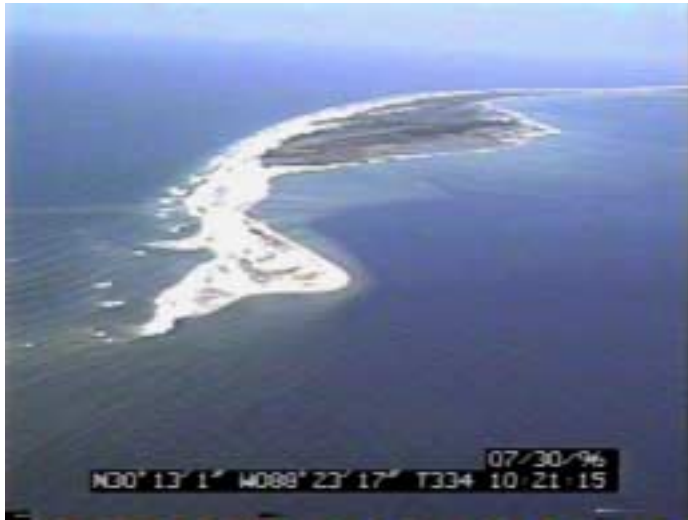
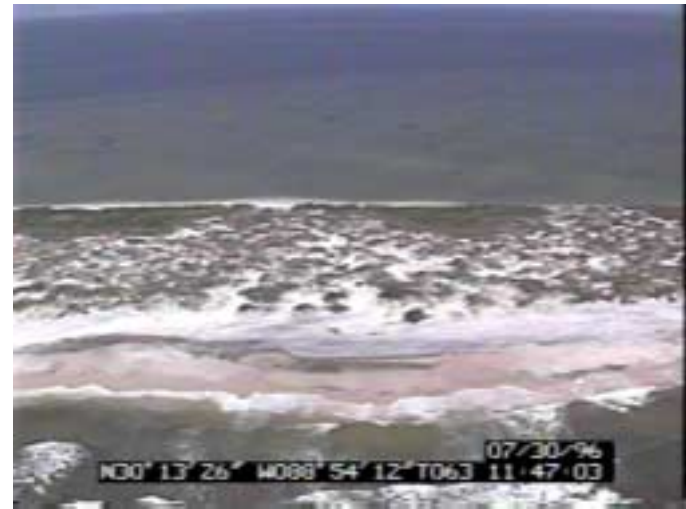
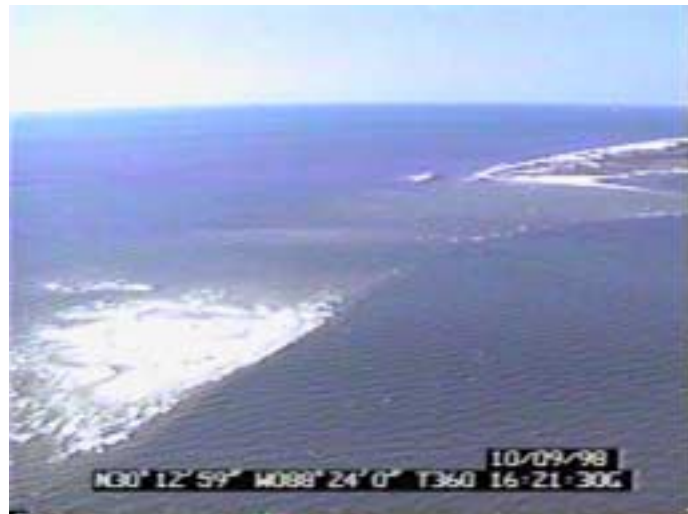
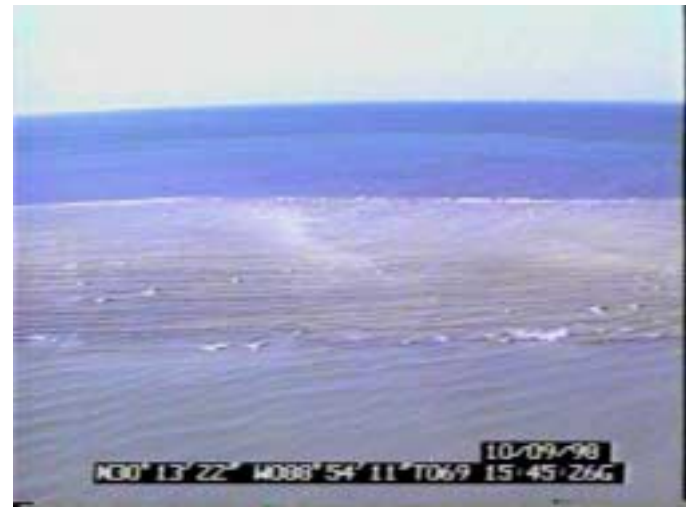
Sand Shoals

P. Bois Is.

E. Ship Is.

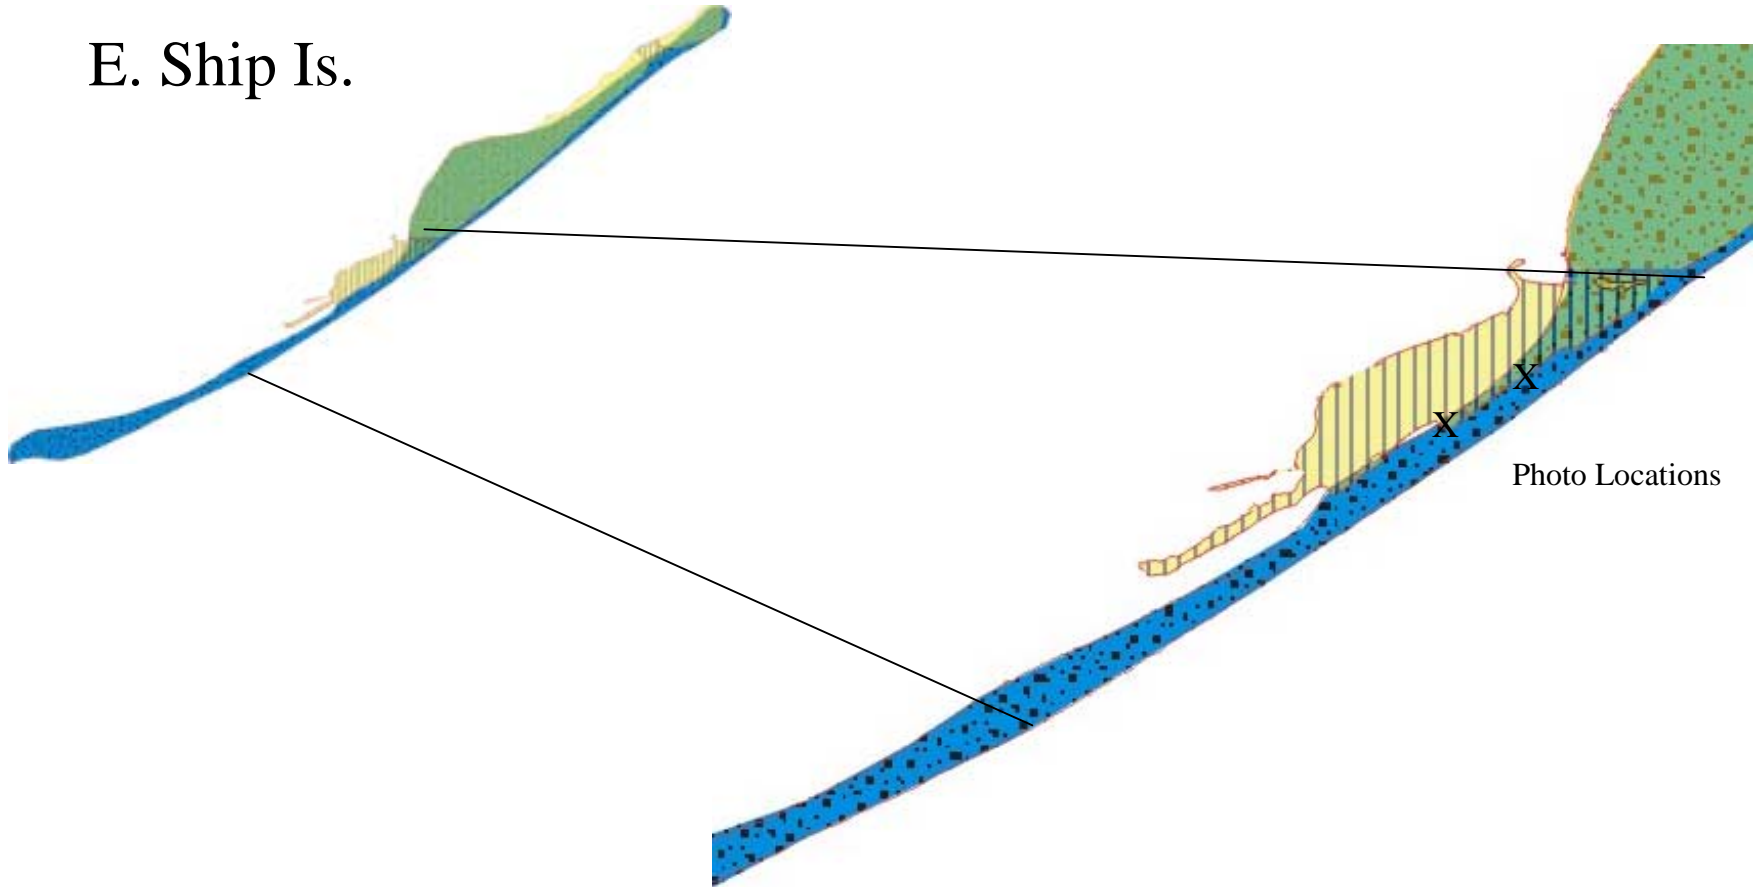
Photo Locations

Island Recovery

E. Ship Is.

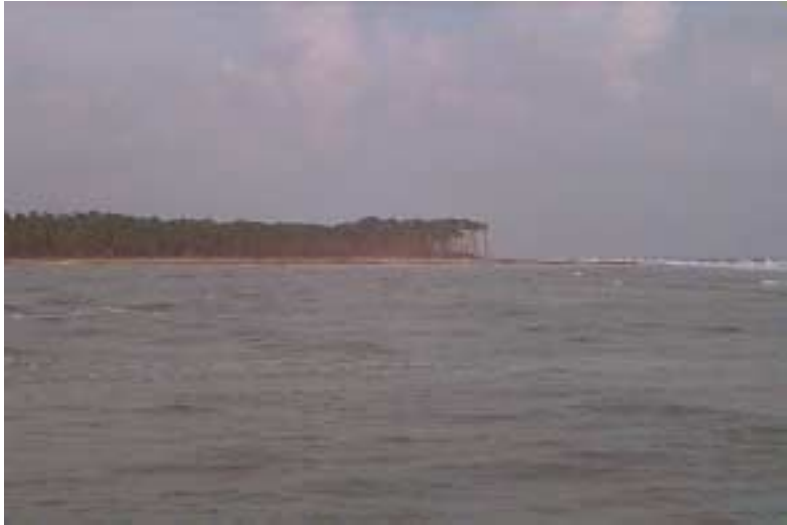
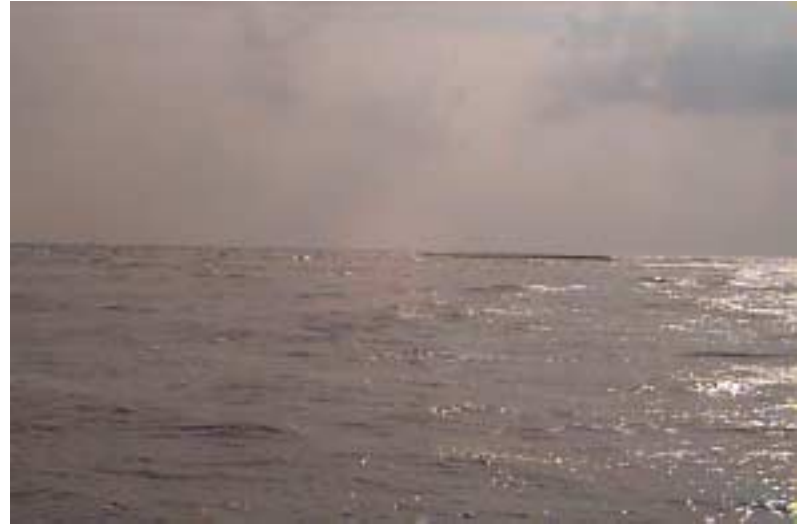
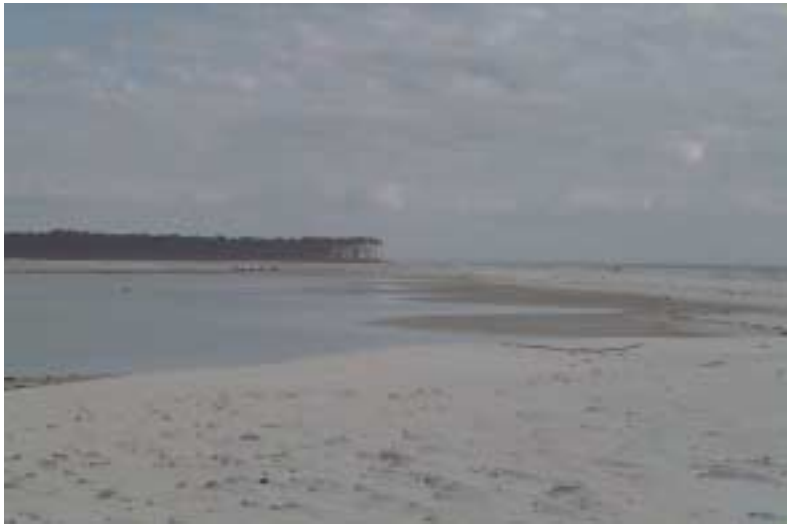
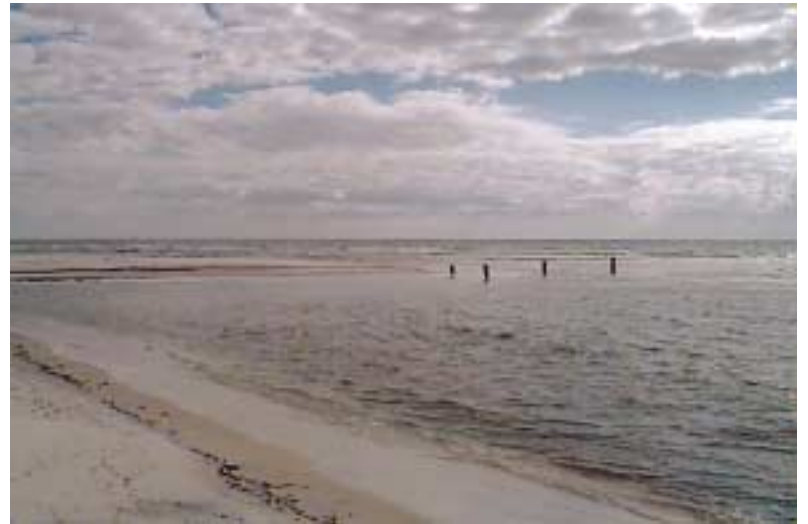
Island Recovery

10/98

01/99

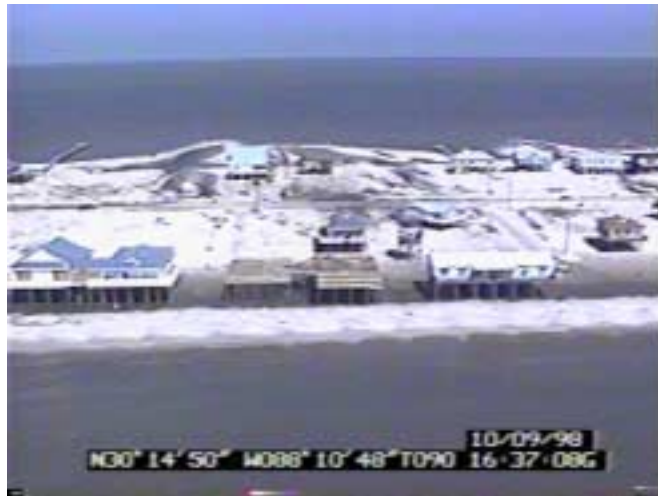
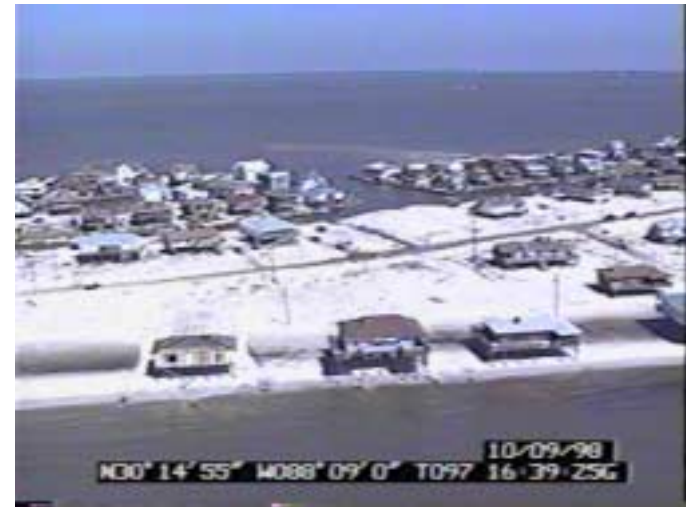
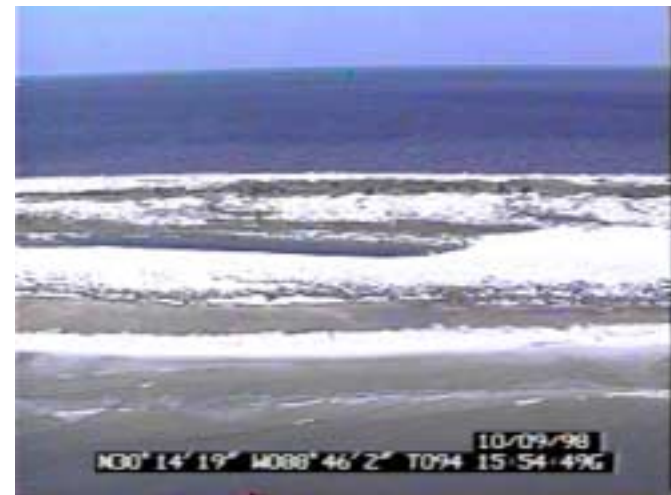
Inhabited Shoreline Responses

Dauphin Island Vs. Horn Island

- Similar over-wash patterns
- Distinctly different outcomes
- Mitigation Vs. Migration
